Report Summary Page

Exterior Components

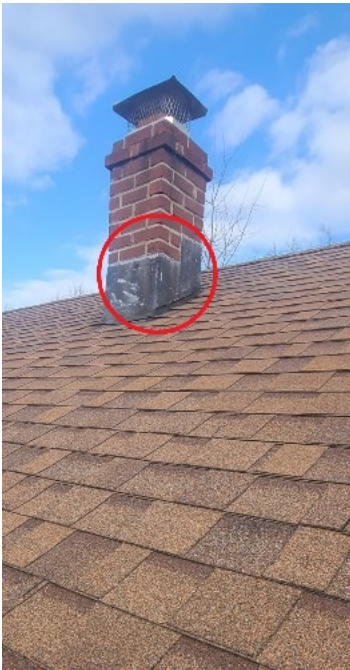
3.3 Chimney Conditions

Observed roofing cement applied on the chimney. While this may be a temporary fix, it's not a long-term solution. It's advisable to consult a professional roofer to assess and address any underlying issues, ensuring a more durable and effective repair.

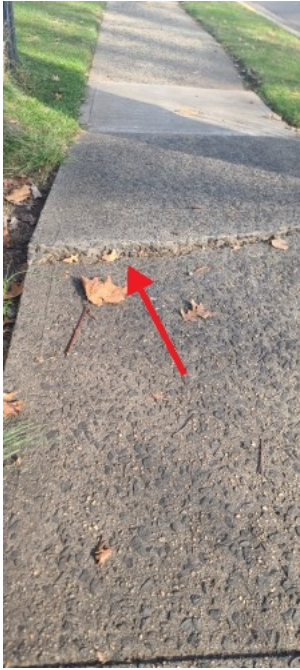
3.17 Sidewalk Conditions

The sidewalk shows signs of either raising or settling. This can pose a tripping hazard. Suggest engaging a professional contractor to assess and address the issue for proper sidewalk stability.

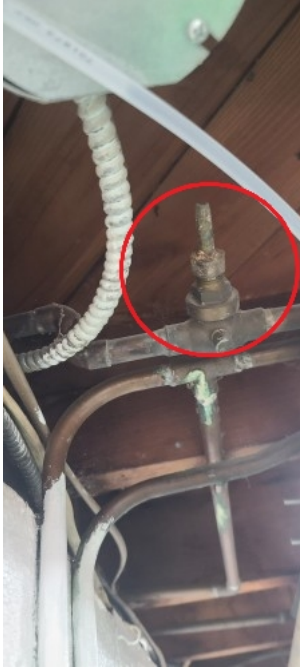
5.1 Plumbing Conditions

The valve wheel was missing in the laundry room. This could impede the ability to shut off or control the flow of water to this area, which poses a potential safety and functionality concern. It is recommended that the missing valve wheel be replaced promptly to ensure proper operation and safety.

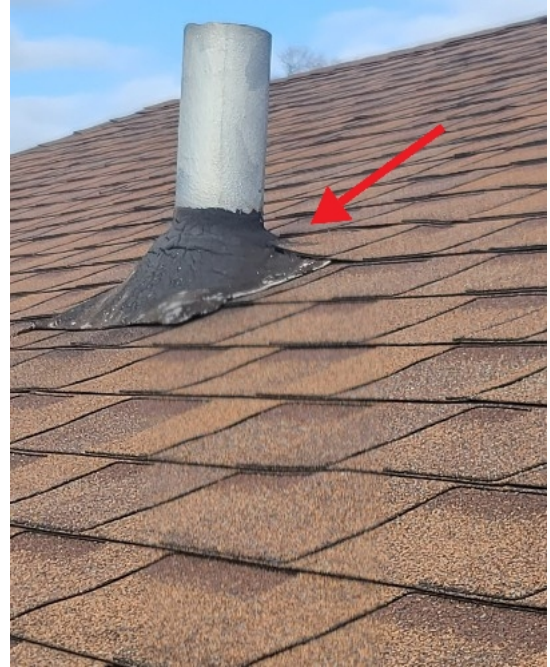
Roofing cement-like material around the plumbing vent stack flashing. This could indicate an attempt to address a leak, but it's recommended to have a professional roofer inspect and make necessary repairs to ensure the proper sealing and integrity of the flashing.

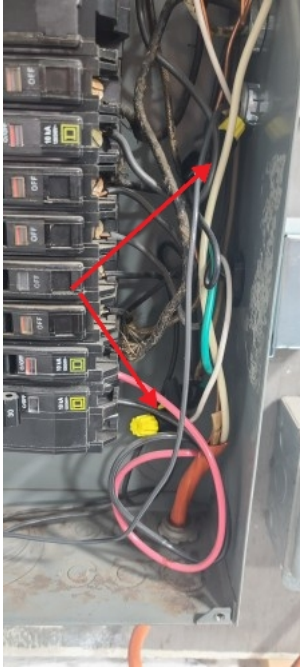
6.1 Electrical Conditions

Multiple splices wires inside the main electrical panel. This poses a safety risk and should be addressed promptly by a qualified electrician to ensure compliance and prevent potential hazards.

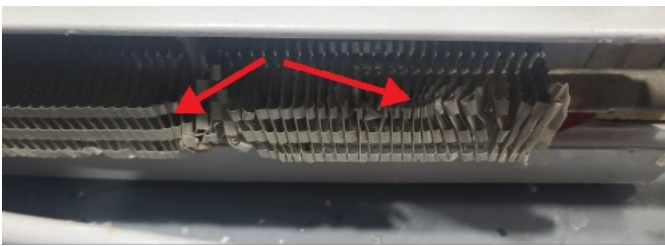
7.1 Heating System Conditions

The heater coils exhibit noticeable dents and damage. These issues may impact the heating efficiency and pose potential safety concerns. It is advised to address and rectify the damage promptly to maintain optimal functionality and prevent further complications.
